**RULING OF THE MARITIME DISCIPLINARY COURT OF THE NETHERLANDS OF  
27 JANUARY 2023 (NO. 1 OF 2023) IN THE CASE 2022.V6– EN AVANT**

The petition for a disciplinary hearing was filed in response to the accident described below.

On 25 August 2021, at around 11.09pm LT, a very serious accident occurred on board the tug EA7. The accident led to the death of a seaman, and a trainee was injured. The accident took place in Centrale Insteekhaven at Moerdijk. The EA7 was performing port assistance, as a stern tug. The ocean-going vessel being assisted was the Tia Marta. The En Avant 4 was involved as a bow tug. The Tia Marta was towed astern out of the Oostelijke Insteekhaven before being turned into the swinging circle of the Centrale Insteekhaven before turning ahead towards Zuid-Hollands Diep. During this manoeuvre, the seaman and the trainee became trapped between the towline and the accommodation. The seaman died of his injuries almost immediately. The trainee suffered two broken ribs.

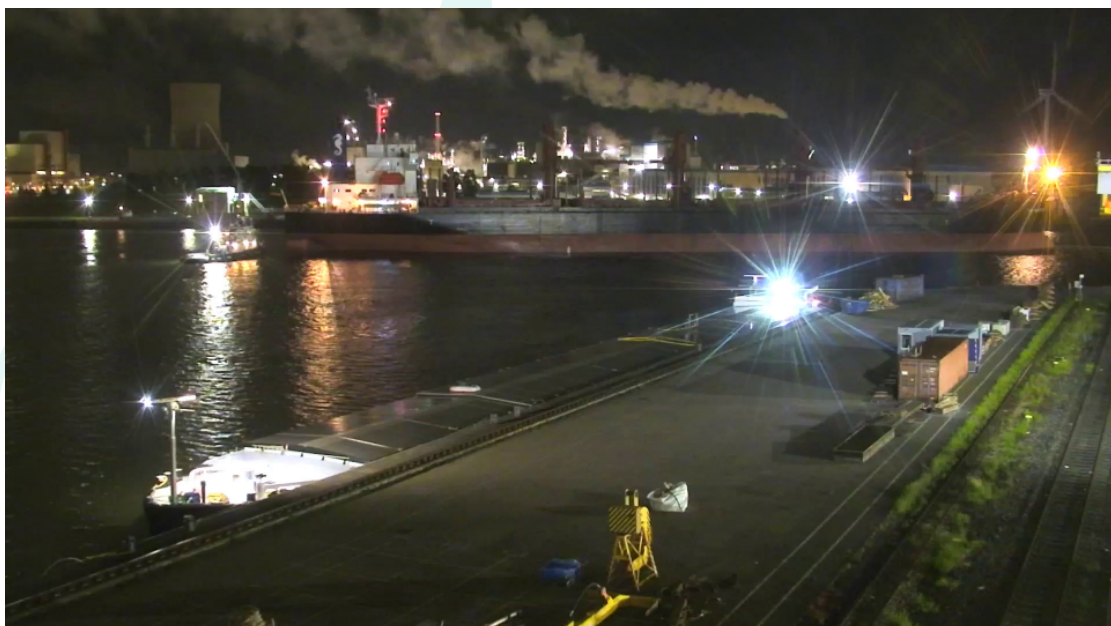
Screenshot 31 - CAM 4211, after 16:56 film

- After 16 minutes and 55 seconds, this person disappears from view again as he walks towards the bow;
- After about 16 minutes and 55 seconds, the EA7 has turned too far (see screenshots 31 and 32 of photo sheet DOC-016);

The EA7 turned too far to port, causing the towline to conflict with the accommodation/superstructure of the EA7. The towline is not under tension here.

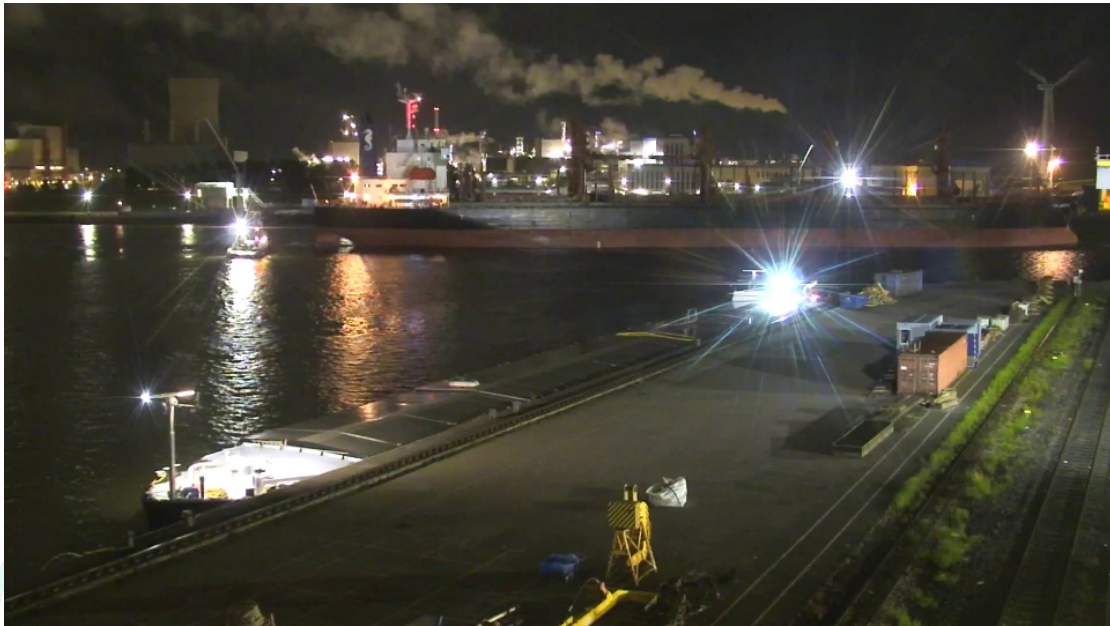
Screenshot 32 - CAM 4211, after 17:10 film

- After 17 minutes and 10 seconds, the towline tightens and the bow of the EA7 abruptly pulls towards the Tia Marta (see screenshot 32 of photo sheet DOC-016);

The EA7 turned even further to port. This is the moment when the towline becomes tight/under tension. This is also when the accident happens/just happened. That is at 23:09:09 (hour:min:sec), or just a few seconds before.
