**RULING OF THE MARITIME DISCIPLINARY COURT OF THE NETHERLANDS OF
27 JANUARY 2023 (NO. 2 OF 2023) IN THE CASE 2022.V7– EN AVANT**

On 25 August 2021, at around 11.09pm LT, a very serious accident occurred on board the tug EA7. The accident led to the death of a seaman, and a trainee was injured. The accident took place in Centrale Insteekhaven at Moerdijk. The EA7 was performing port assistance, as a stern tug. The ocean-going vessel being assisted was the Tia Marta. The En Avant 4 was involved as a bow tug. The Tia Marta was towed astern out of the Oostelijke Insteekhaven before being turned into the swinging circle of the Centrale Insteekhaven before turning ahead towards Zuid-Hollands Diep. During this manoeuvre, the seaman and the trainee became trapped between the towline and the accommodation. The seaman died of his injuries almost immediately. The trainee suffered two broken ribs.

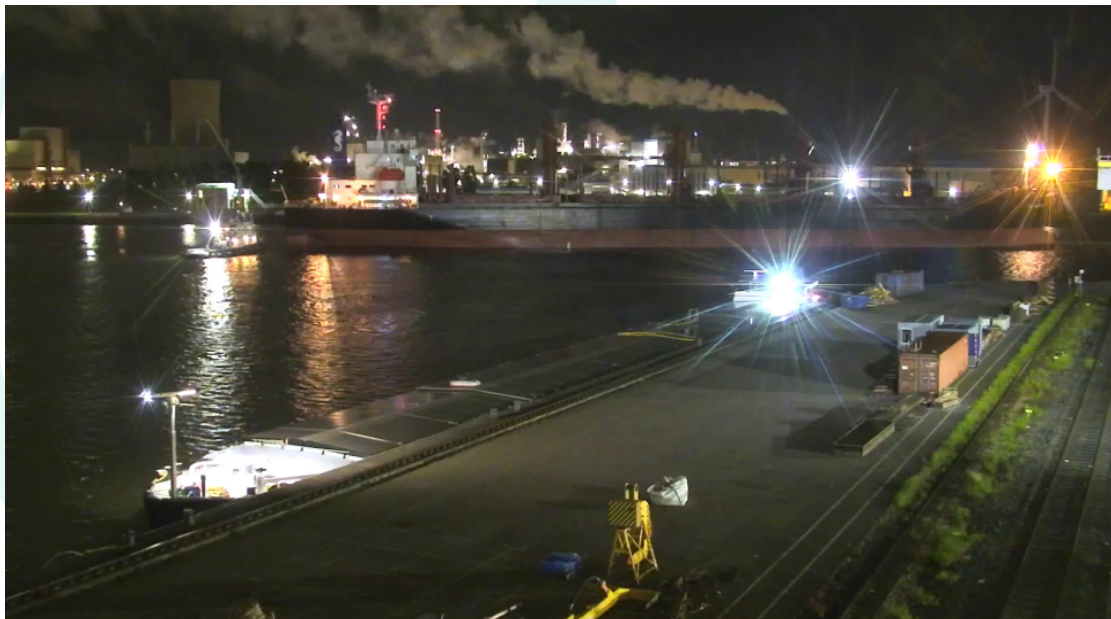
Screenshot 31 - CAM 4211, after 16:56 film

The EA7 turned too far to port, causing the towline to conflict with the accommodation/superstructure of the EA7. The towline is not under tension here.

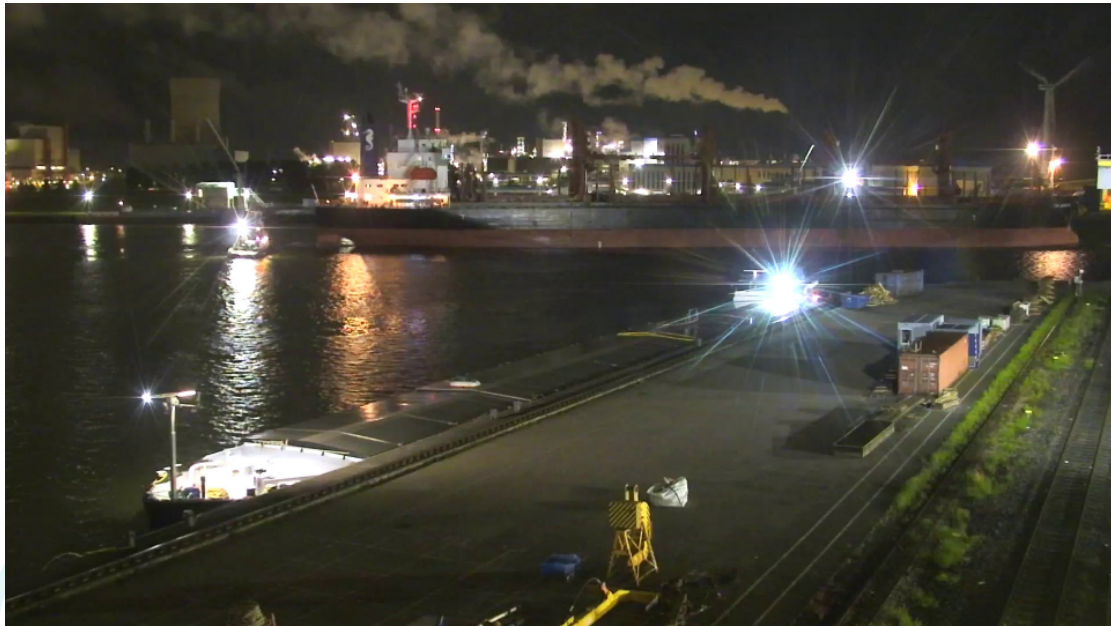
Screenshot 32 - CAM 4211, after 17:10 film

The EA7 turned even further to port. This is the moment when the towline becomes tight/under tension. This is also when the accident happens/just happened. That is at 23:09:09 (hour:min:sec), or just a few seconds before.
